Inspections of water and thermal wells

(Gábor Szongoth geophysicist)

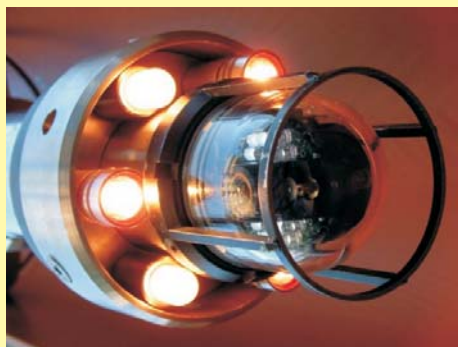
Head of well camera

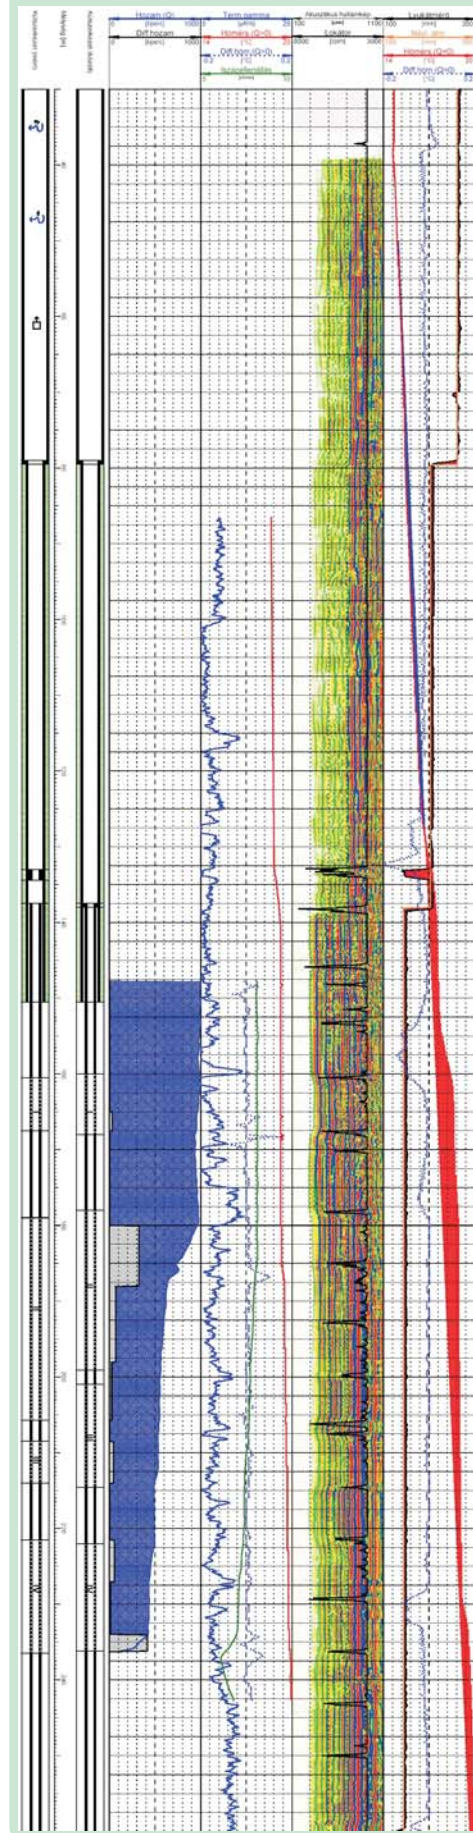
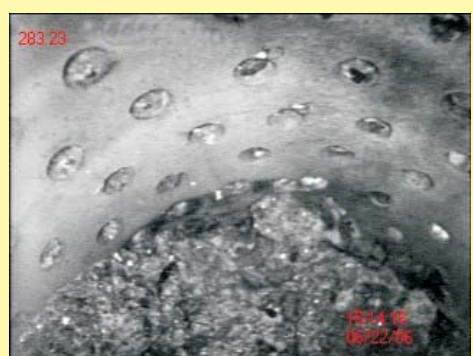
The well was producing sandy water and the water was colder than the prospective, because of this we made a total well inspection.

According to full wave sonic measurement the 2nd and 3rd screens were not in the provided places. The Gamma Ray measurement informed us about the geophysical column and the fluid flow log showed the distribution of yield.

The caliper log showed the sealing box is in 132 m depth. The decrease of the temperature documented just here the punctured pipe near the sealing box. Here got in the sand and colder water in the inside of the well.

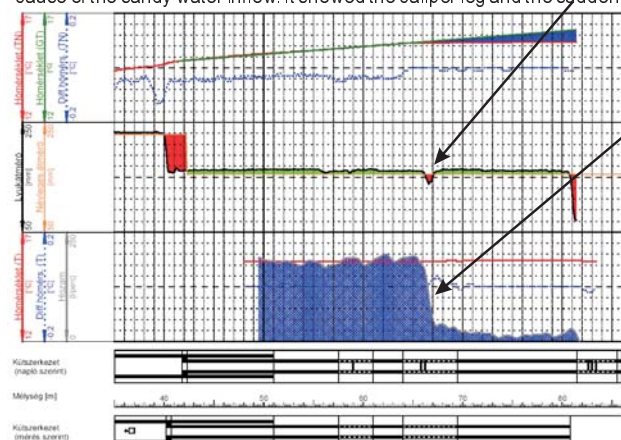
Sediment accumulation in plastic screen pipe

Tore screen

In this well we made a total well inspection to reveal the causes of sandy water and yield decreasing. According to measurements the well was partially filling up with sand. The clogged 3rd screen is the cause of decreasing yield. The in 67,5 m depth tore screen was the cause of the sandy water inflow. It showed the caliper log and the sudden increasing yield too.

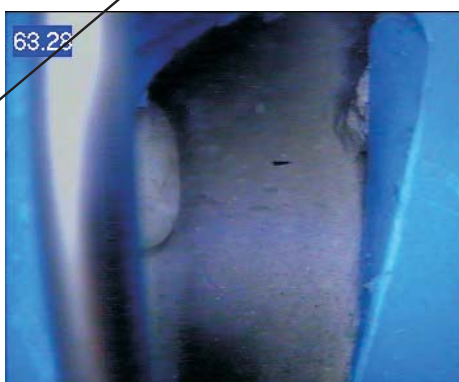
Damaged screen
