Complex mineral water well inspection

6th Congress of the Balkan Geophysical Society, 3rd-6th October, 2011, Budapest, Hungary

József Buránszki senior geophysicist, Geo-Log Ltd., Budapest
 Gábor Szongoth senior geophysicist, Geo-Log Ltd., Budapest
 András Prohászka geologist, Geo-Log Ltd., Budapest
 Sándor Hegedűs geophysical engineer, Geo-Log Ltd., Budapest
 Zsófia Kalotai environmental scientist, Geo-Log Ltd., Budapest

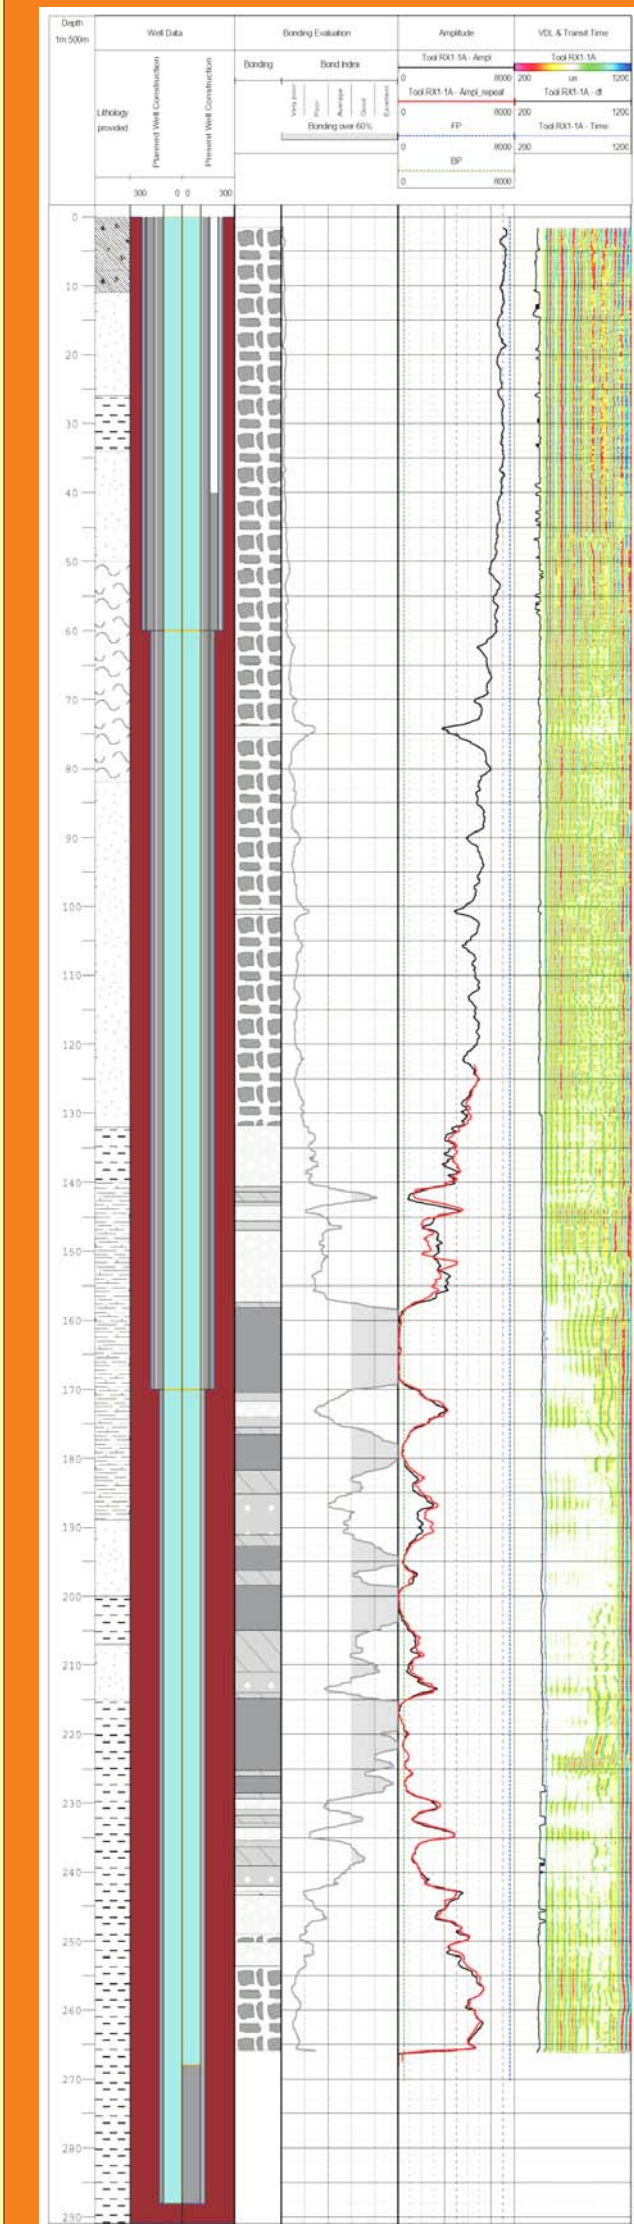
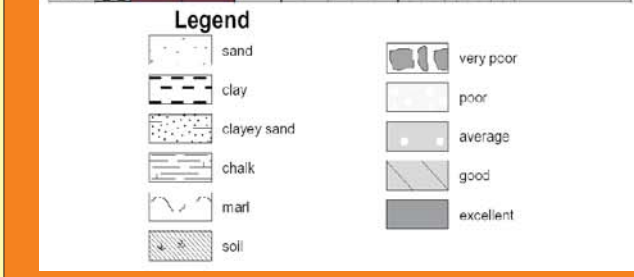
Very low Bond Index values could be observed above the depth of 157 m, especially above 132 m. Fortunately, this zone is above the bottom of surface casing. The bottom of this casing is found in a better zone between 132 and 157 m, in which the Bond Index shows excellent and good bonded zones, with some relatively thin parts of poorer quality. In this interval the better bonded zones tend to accompany the clay beds. After a heterogeneous, but generally average quality bonding interval 229-241 m, the Bond Index is lower than 10% down to the bottom. Since a thick clay bed is assumed to be between 215 and 292 m, with an excellently bonded zone nearby its upper zone, this interval blocks out any leakage coming potentially from the upper sand beds. The deepest 25 m of the well were filled by bonded cement, so that there is no information about it.

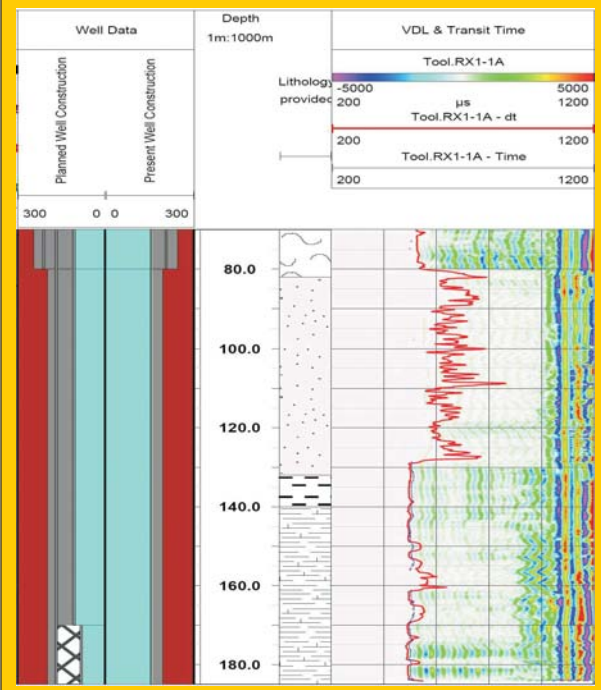
An extraordinary well bonded part is due to the permeable sand bed which is generally invaded excellently by the slurry. In this zone even the formation waves are vanished.

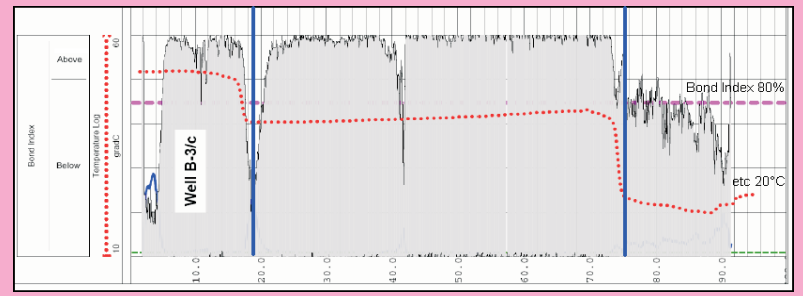
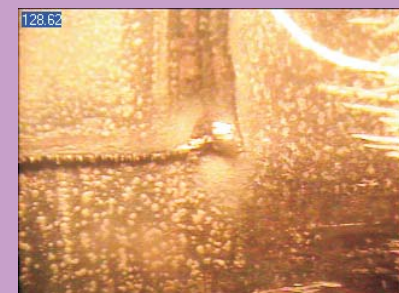
The wide (610/594 mm) PVC pipe deformed considerably due to the heat produced during the consolidation of the cement. The well was professionally sealed and a new well was established a few hundred meters away. The cementing in this later case was already implemented in three consecutive steps, therefore, considerable amount of heat was not produced. The lower figure presents the size of the new well after cementing. The thermal curve and CBL were taken 48 and 72 hours after the latest episode of cementing respectively. The measurements illustrate nicely the episodic nature of cementing, because the uppermost section is still warm due to the consolidation of cement. At ~20 m the contact between the two cement surface is of poor quality based on CBL section - and below 75 m the cementing has, again, weak quality, which is confirmed by the temperature ~20°C that resembles closely the original temperature of the rock. In summary, the good quality of cementing (consolidation is in the excess of 80%) between 21-74 m ensures the blocking of downward flowing pollutions.

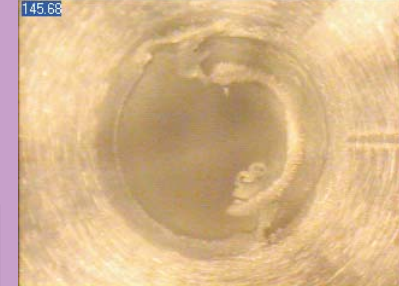
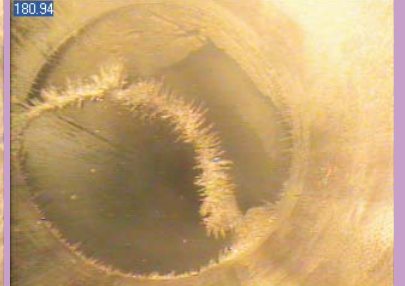
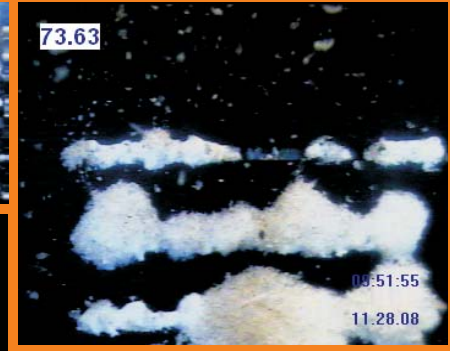
Investigation of a steel pipe got damaged during the drilling. During the drilling of a well aimed at producing bottled water, the contractors experienced several challenges, as they had to save several occasions, and consequently their 36 5/34 mm sized pipe (not a brand new one) got damaged (deformation, sliding off) and at some places the boring tool got stuck. The following images illustrate these damages. The damaged steel pipe was, however, completed as the contractors saved the stuck instrument and went on with the drilling of the well. The well was successfully completed as yielding 300 l/min good quality water, but to achieve this was a little bit challenging.

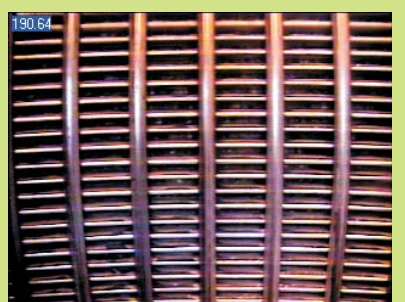
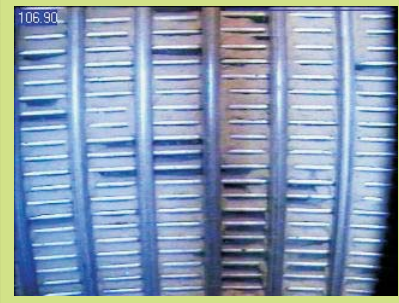
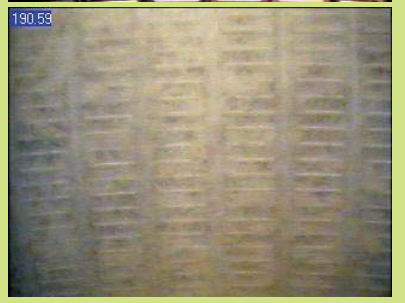
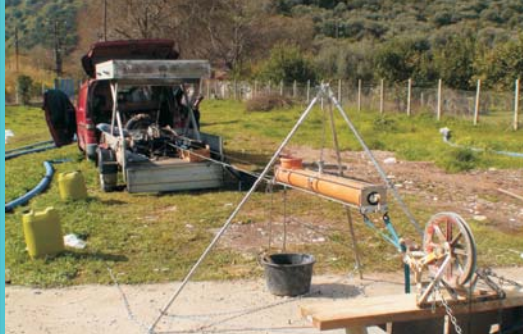
It is crucial for a completed well that the entire surface of the filter is clean, because this makes sure that the well gives water without sand and the yield is maximal. In the figures below we demonstrate how a clean filter surface and another surface, which is yet to be cleaned, look like. The experience tells us that the monitoring of filters with camera is very effective, since we have checked several new wells where the filter surface was entirely clean only after the third occasion. The procurer could only convince the drillman about the need of effective filter-cleaning when presented these images.
